ACOUSTIC TESTS ON THE WALKER MEMORIAL HALL, BIRMINGHAM

Technological Report No. B-089/1  
UDC 534.861.1 1966/4

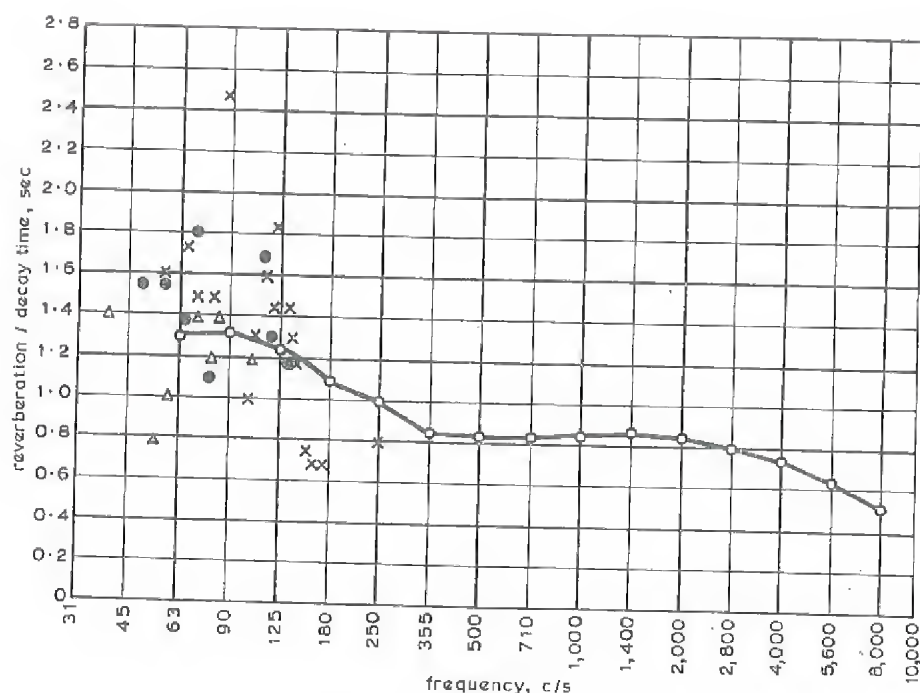
Fig. 1 - Measurements before modification

Fig. 1 shows the reverberation curve of the hall before alteration. There was a steep rise at low frequencies, reaching 1.3 sec at 90 c/s. There was also a general maximum centred on 1400 c/s. The high reverberation times at low frequencies were associated in many cases with marked double decays. There were long rings heard when pulsing the studio with tone of frequencies up to 1 kc/s or more, apparently associated with the maximum of the curve in this region. These rings were found to be connected with standing-wave systems between the floor and ceiling. They could be treated by absorbers mounted on the ceiling.

was attached to various points on the floor and the hall again excited by tone from the loudspeaker. The decay times were measured at every frequency at which there was a maximum of floor vibration. Two groups of accelerometer positions were chosen, one group on the centre line between two sleeper walls and the other over the sleeper walls. The decay times are plotted in Fig. 1 against the frequencies of maximum resonance. It will be seen that the points are all in the region of maximum room reverberation time and that many are well above the reverberation curve.

The relationship between the floor measurements and the reverberation curve was taken as a strong indication that floor resonances accounted for the double-slope decays observed in the reverberation measurements, and therefore for the subjective "boominess" of the studio when used for music. The most important recommendation was therefore that the floor should be stiffened and effectively damped.

About 350 ft<sup>2</sup> (32.5 m<sup>2</sup>) of bonded bass or equivalent absorbers would be required to reduce the low-frequency reverberation to this time and the high frequency reverberation should be increased by the removal of the curtains.

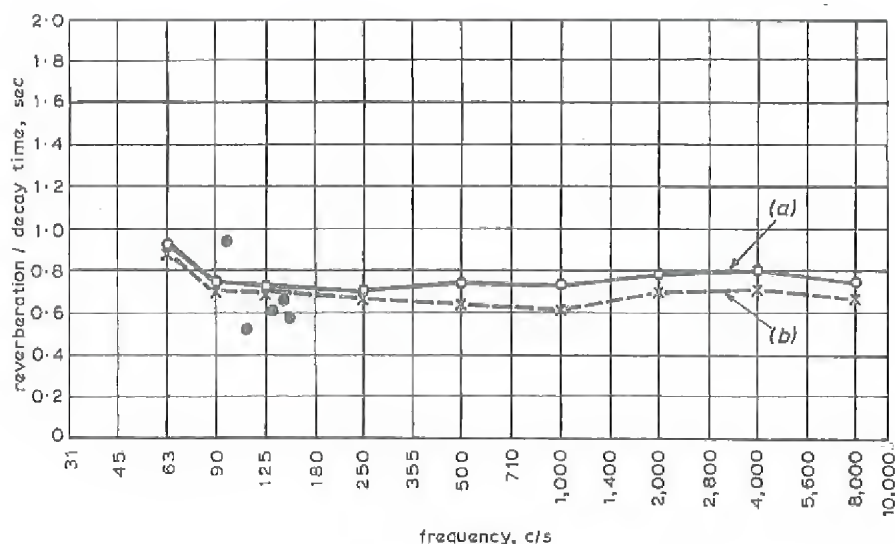
Fig. 2 - Measurements after modification

Subsequent tests were conducted on October 14th 1965, the studio being in the condition described above, except that the stage and curtains were absent. The measured reverberation-time curve is displayed in Fig. 2(a) and shows a close correspondence with the design value of 0.75 secs. Curve 2(b) is included in the figure to show the expected changes caused by the addition of the stage curtains in a "run-back" position. The slight

increase in reverberation times at frequencies above 1 kc/s was noticeable subjectively, the studio having a rather "bright" sound.

Accelerometer measurements of the vibration of the floor are included in Fig. 2 and show that the modifications to its structure have been successful in eliminating the high Q of the resonances. All floor vibration decay times are now shorter than, or comparable with, the room reverberation time, and the previously observed colourations due to the floor cannot be heard.

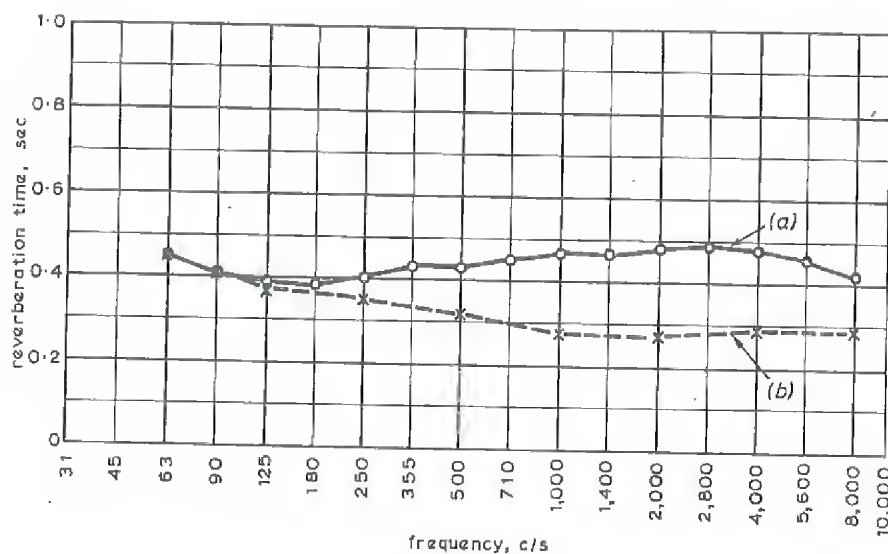
Fig. 3 - Reverberation time of cubicle

Since building operations were still in progress it was not possible to conduct measurements of the transmission losses through the observation window because of the presence of many flanking paths through un-plugged cable ducts, etc. The reverberation time curve for the cubicle is plotted in Fig. 3(a) which, due to the absence of the carpet and console etc. is slightly in excess of the design figure of 0.3 secs. A corrected curve (3(b)) which includes the expected absorption of the carpet, is included in this figure; it shows close agreement with the original design calculations which included the effect of the carpet.
